NASHVILLE FAIRGROUNDS SPEEDWAY

Upgrade Assessment

Prepared by Driven International

L150-DRVN-00-GEN-RP-00-0-01-P02

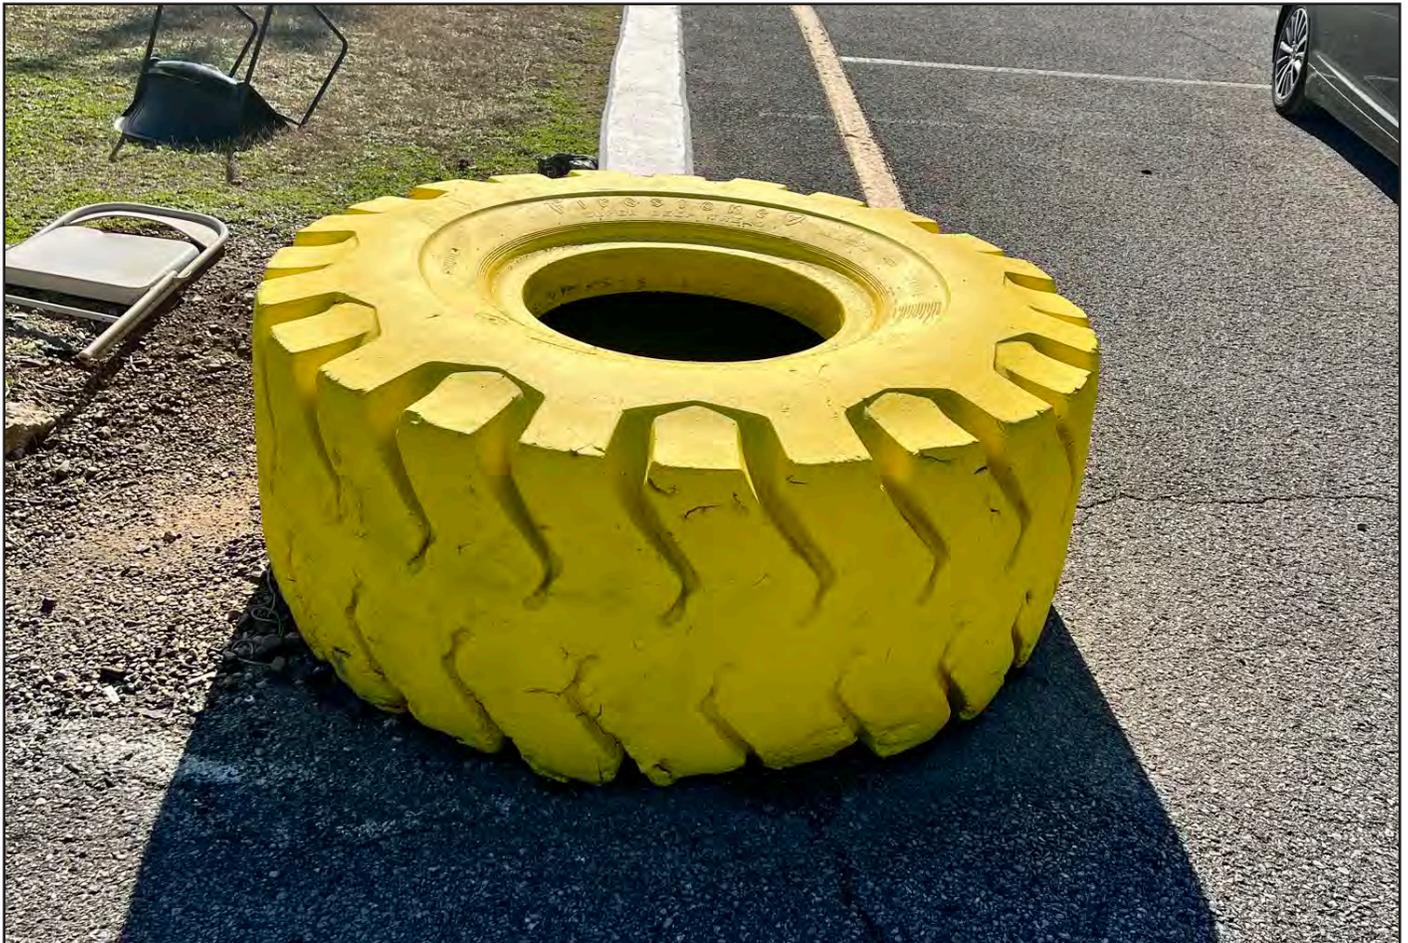
Heavy machinery tyres currently used as attenuator

The use of heavy vehicle tyres as attenuators on the end of exposed concrete walls is not desirable. An upgraded attenuator is recommended to be installed at all exposed concrete wall ends to assist in a scenario where it is hit by a vehicle.

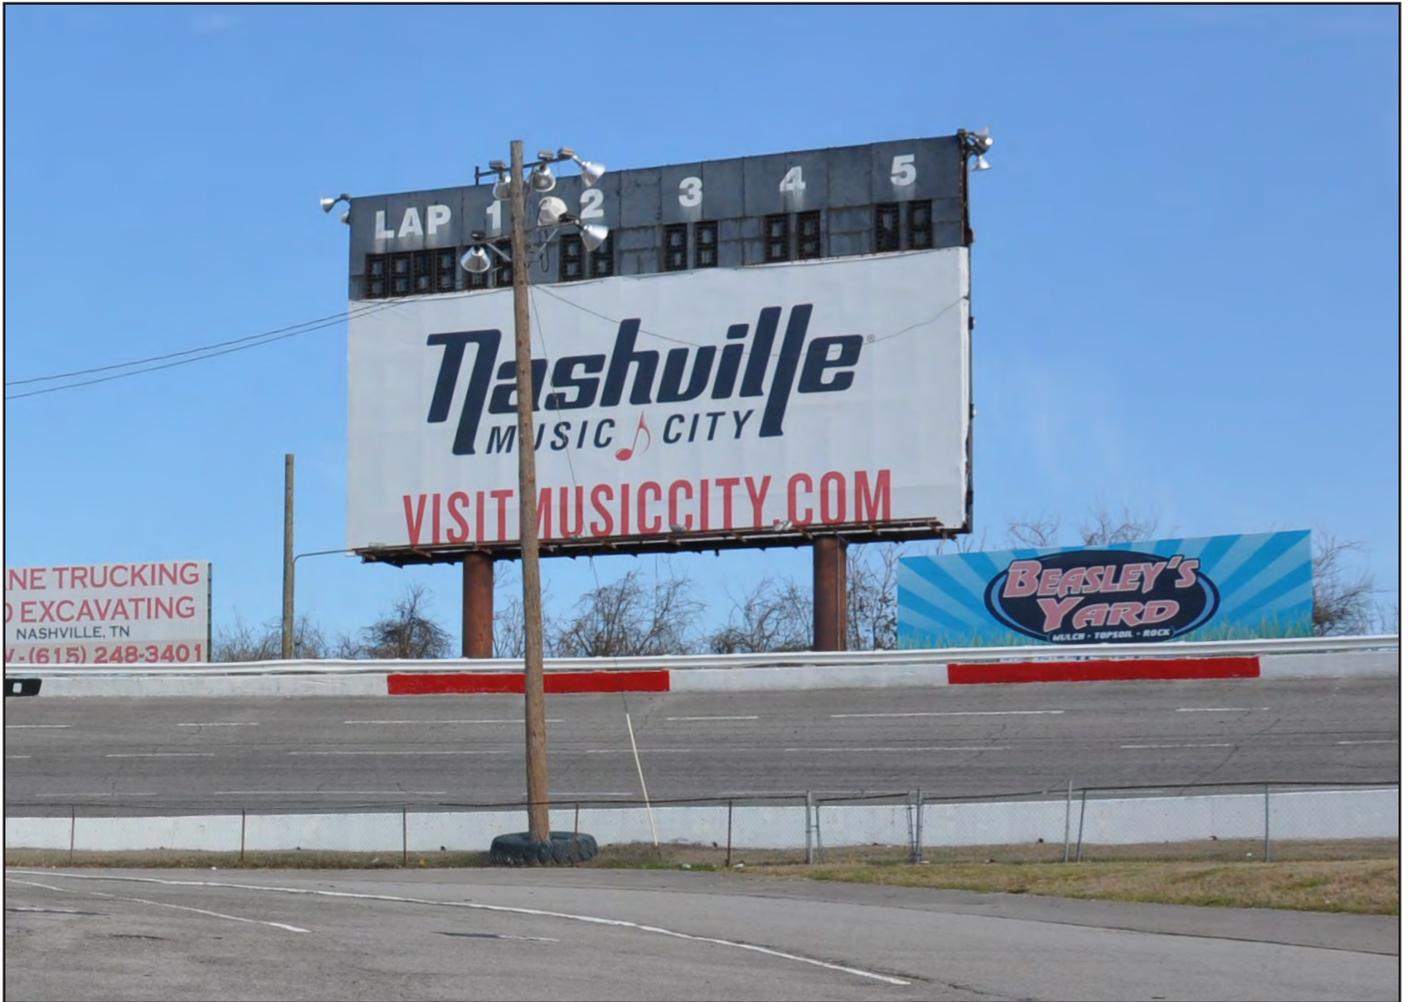
The scoreboard should be updated to a screen capable of displaying more information and advertising

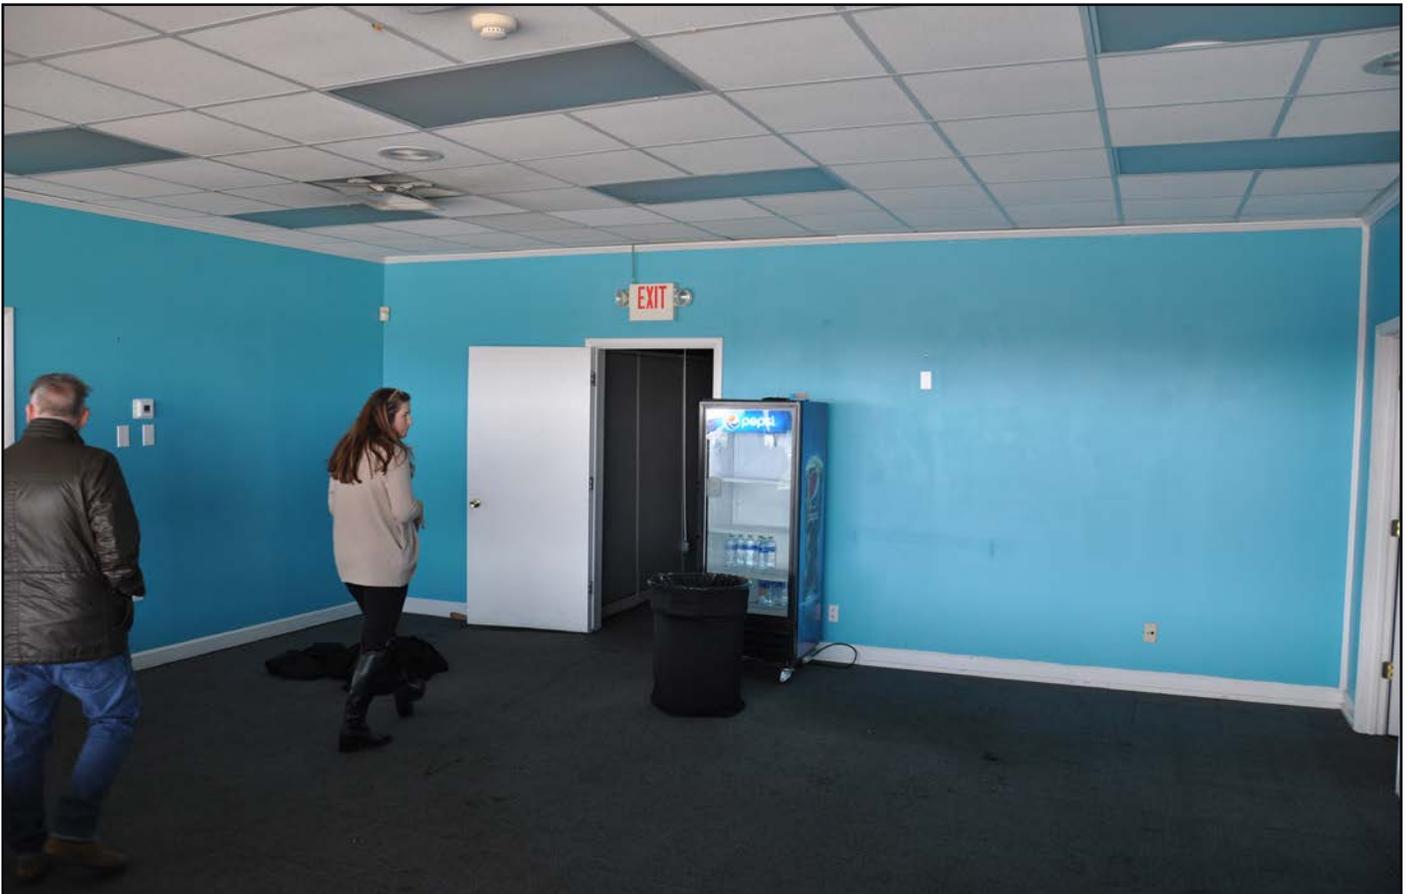
Upper offices and race control areas

The rooms at the top of the grandstand could use a refurbishment to help lift the appearance and experience of the venue and VIP experience. This would include repainting, recarpeting, replacing ceiling tiles, and updating any fixtures and fittings.

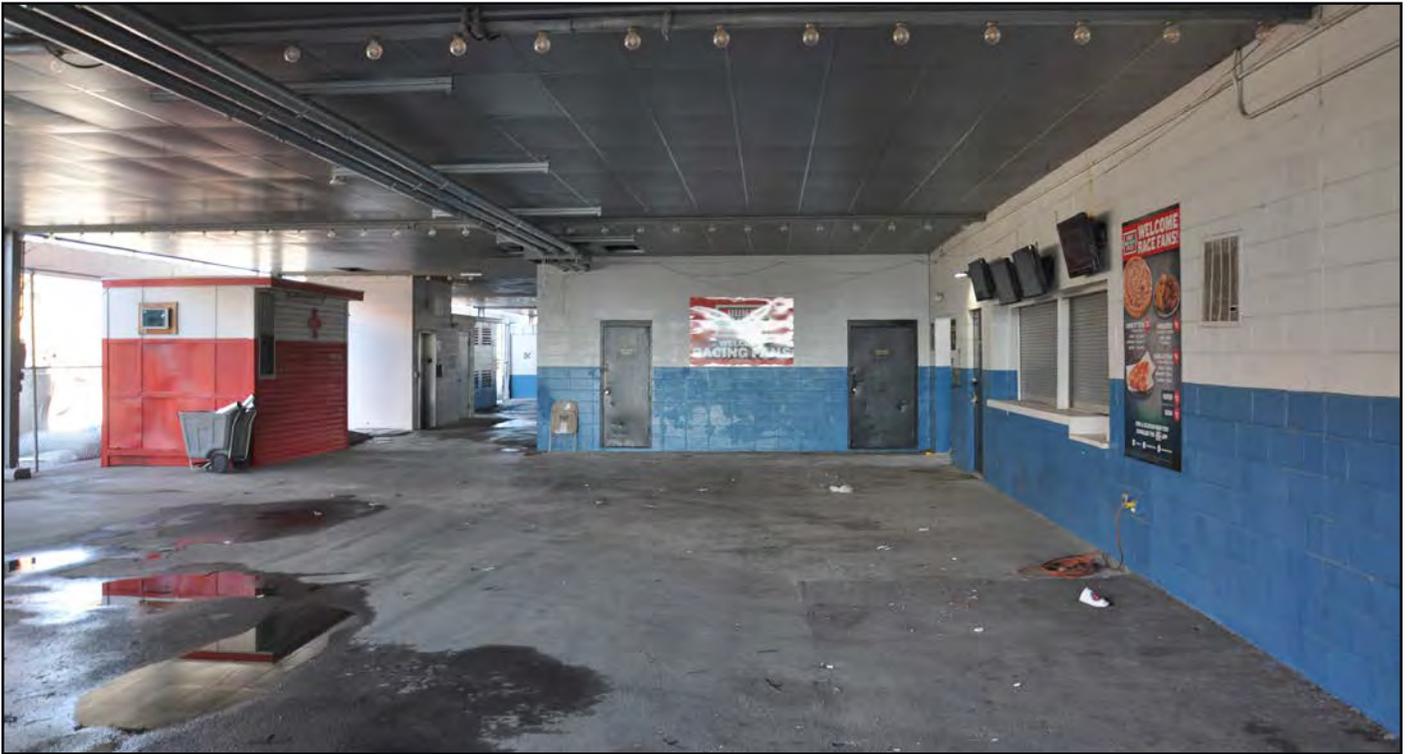
The current concessions area is uninspiring and lacks a range of dining options

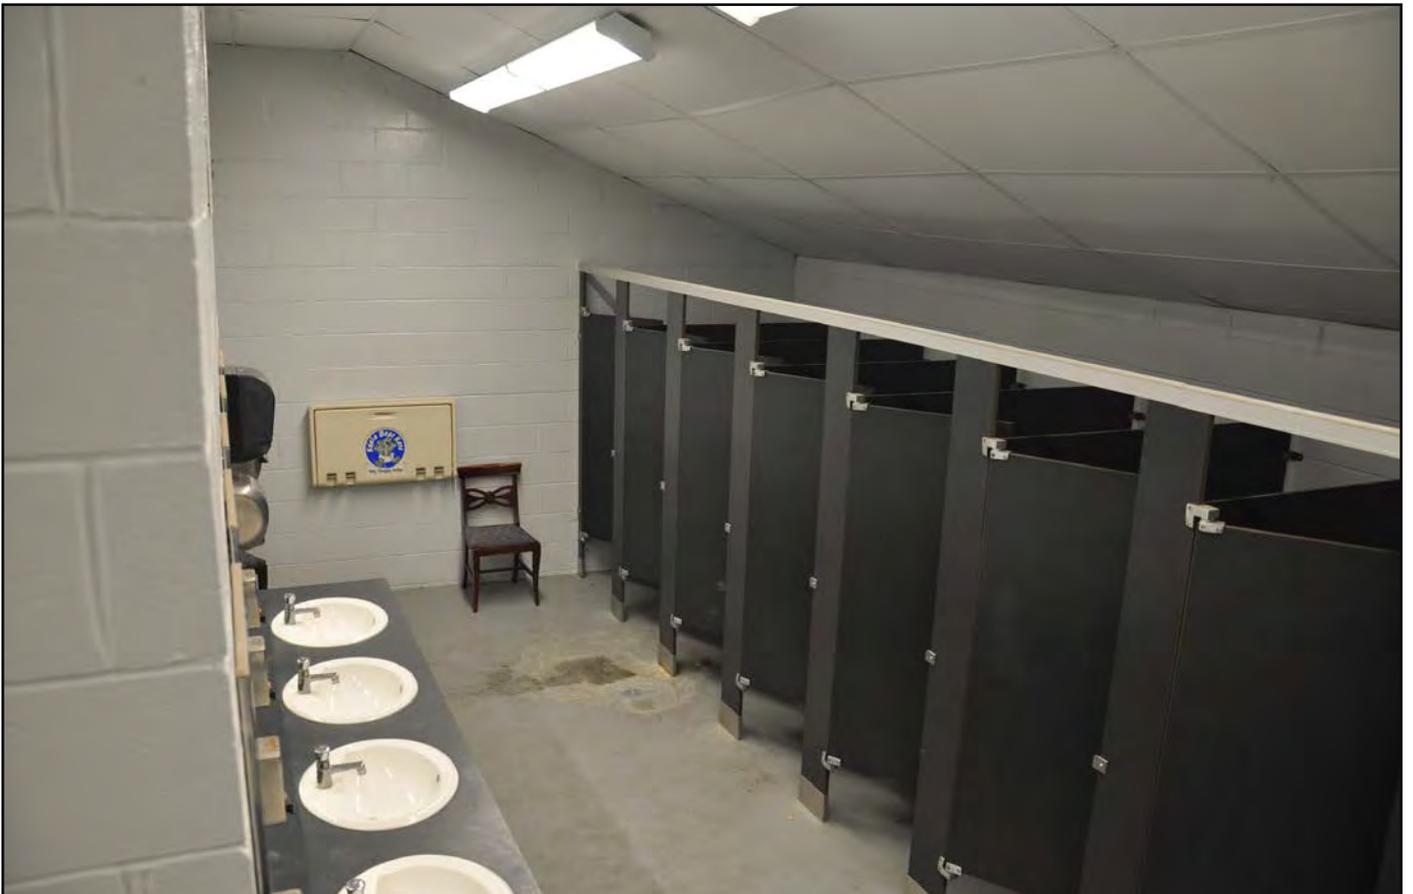
Existing restrooms are functional but in need of refurbishment
